# WIMBA

## WOUND CARE

# Create an optimal healing environment.

# Bruno

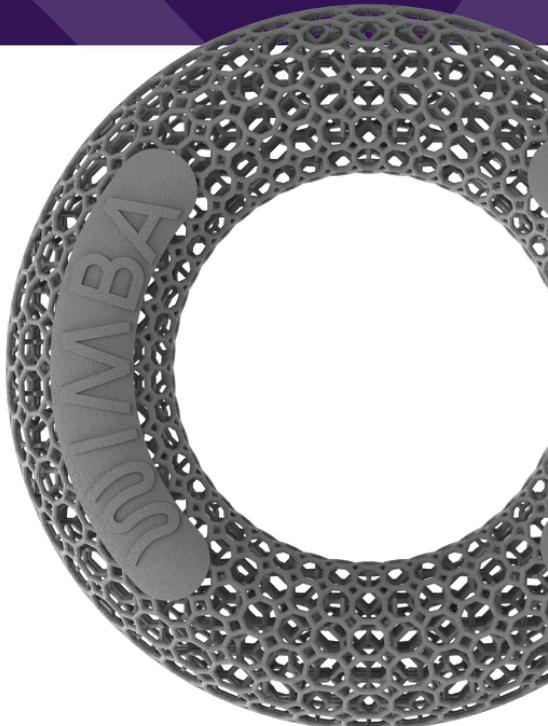
The WIMBA Wound Care protective spacer is an innovative solution for effective wound management in veterinary practice. It forms a protective ring that shields wounds, surgical sites, and calluses from external contact and pressure, creating an optimal environment for healing.

**Printed in 3D technology**  
ensuring breathable and flexible properties.

**Lightweight & durable:**  
for comfort and reliability.

**Pressure relief**  
- absorbs and redistributes forces across a larger surface area.

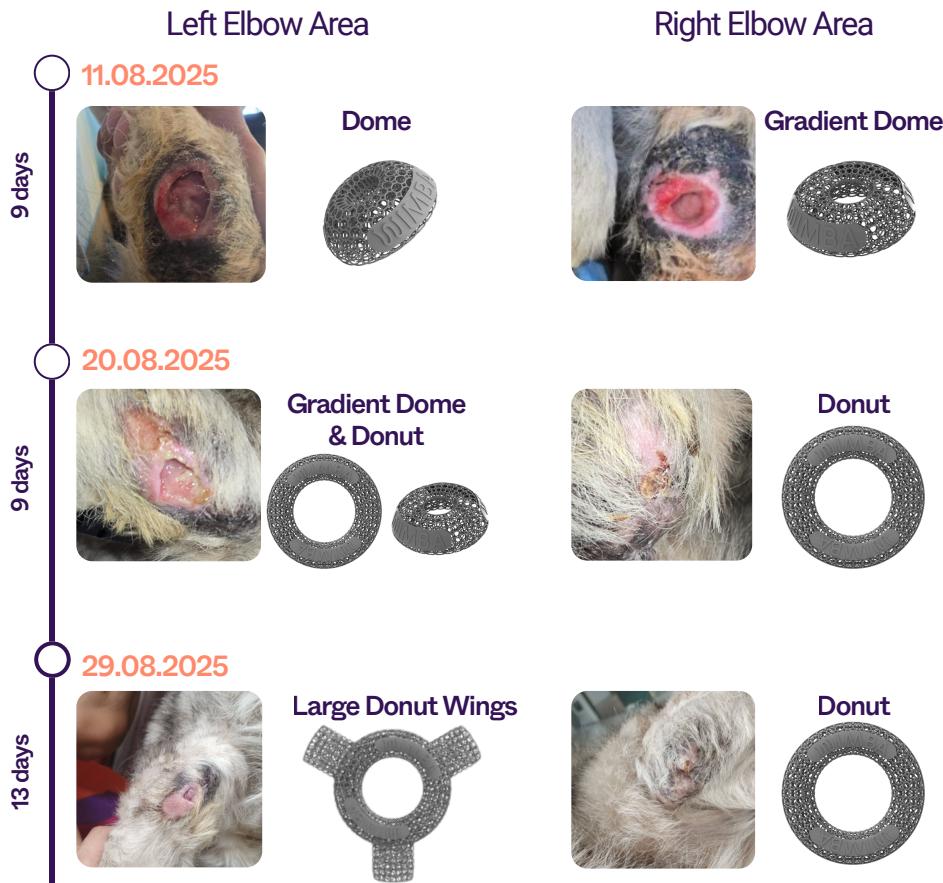
### Protective spacers applied

The approach was selected at each visit based on what kept the dog most comfortable and was practical for the person applying the bandage.

The **Donut** showed the greatest potential—it was soft yet sufficiently rigid not to collapse under the dog's weight. It remained in place both during wrapping and when the dog changed position.

Applying the dressings was difficult because the patient (Bruno) tucked the wounds under himself and rolled onto his side. The functional issue concerned the Dome dressing. Due to its excessive height, the Dome shifted to the side while being secured with a bandage. In addition, when the dog lay down or changed position, this dressing moved, likely encroaching on the wound and potentially irritating it. For this reason, at a later stage,

**Gradient Dome and Dount** were used, which proved more stable. In the latter case, a Winged Donut was applied as a solution to prevent sliding.
